**PURGATOIRE RIVER ASSESSMENT REPORT: PART 1**  
**RIVER HABITAT, HYDROLOGY/HYDRAULICS AND FISHERY BIOLOGY ASSESSMENT**  
**2019-2020**

**Greg Policky – Policky Aquatics, LLC**

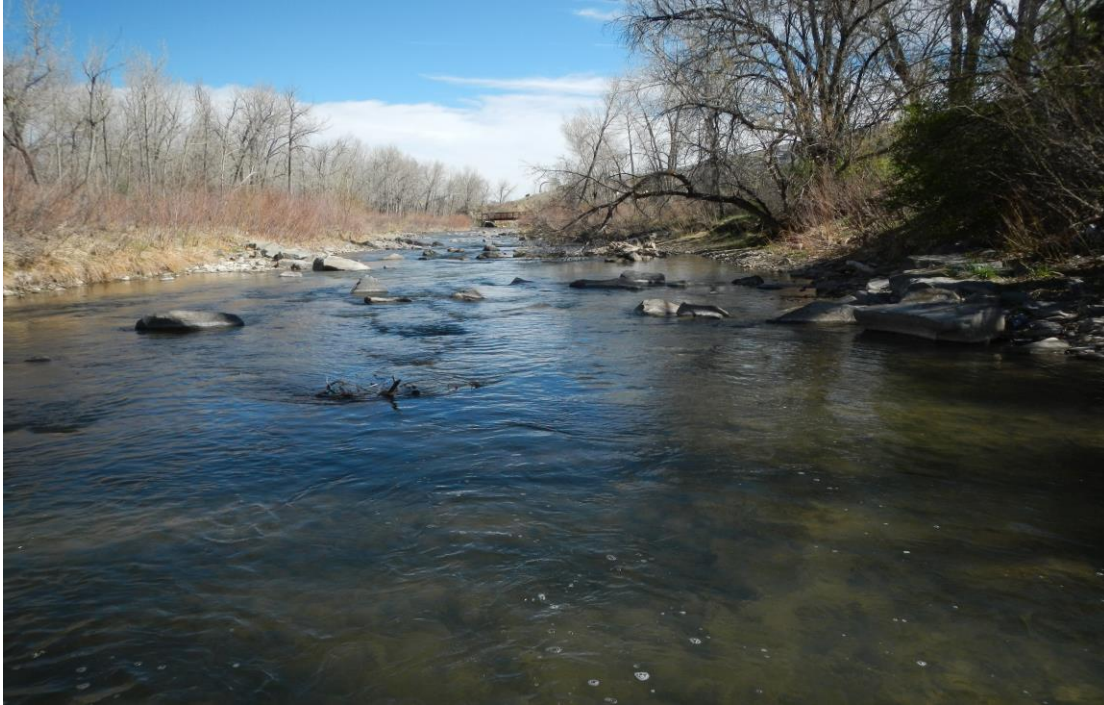
Typical habitat within the Purgatoire River study reach.

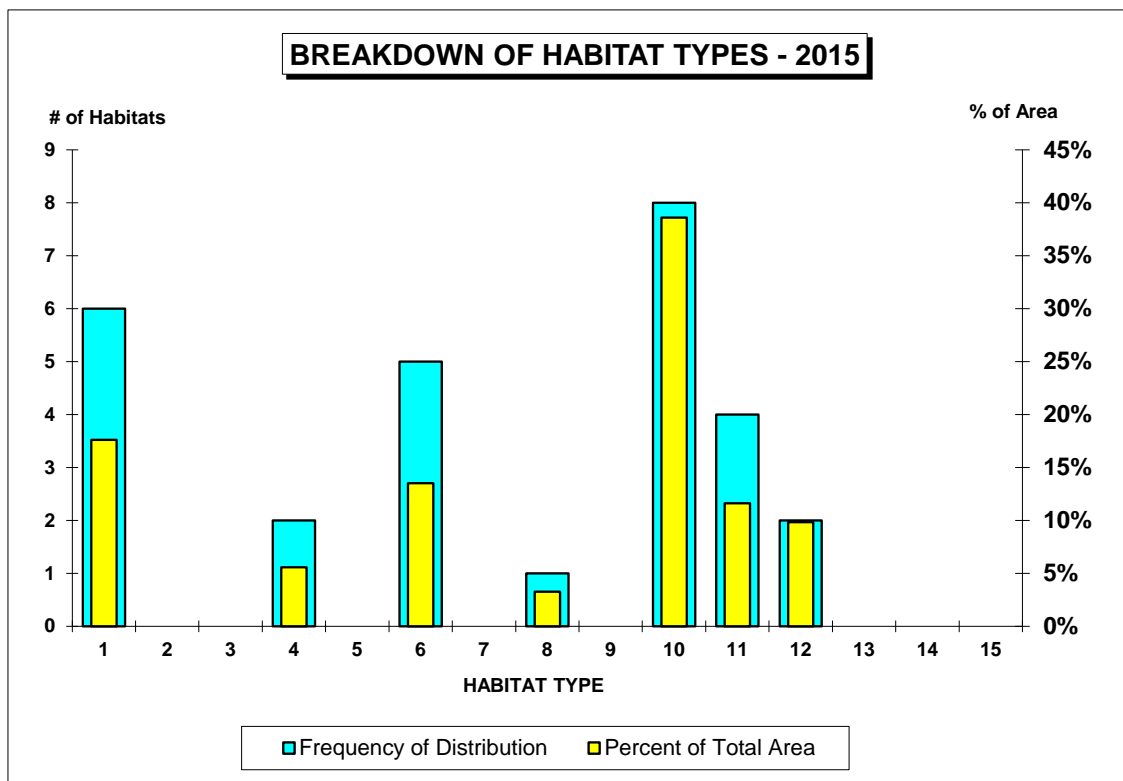
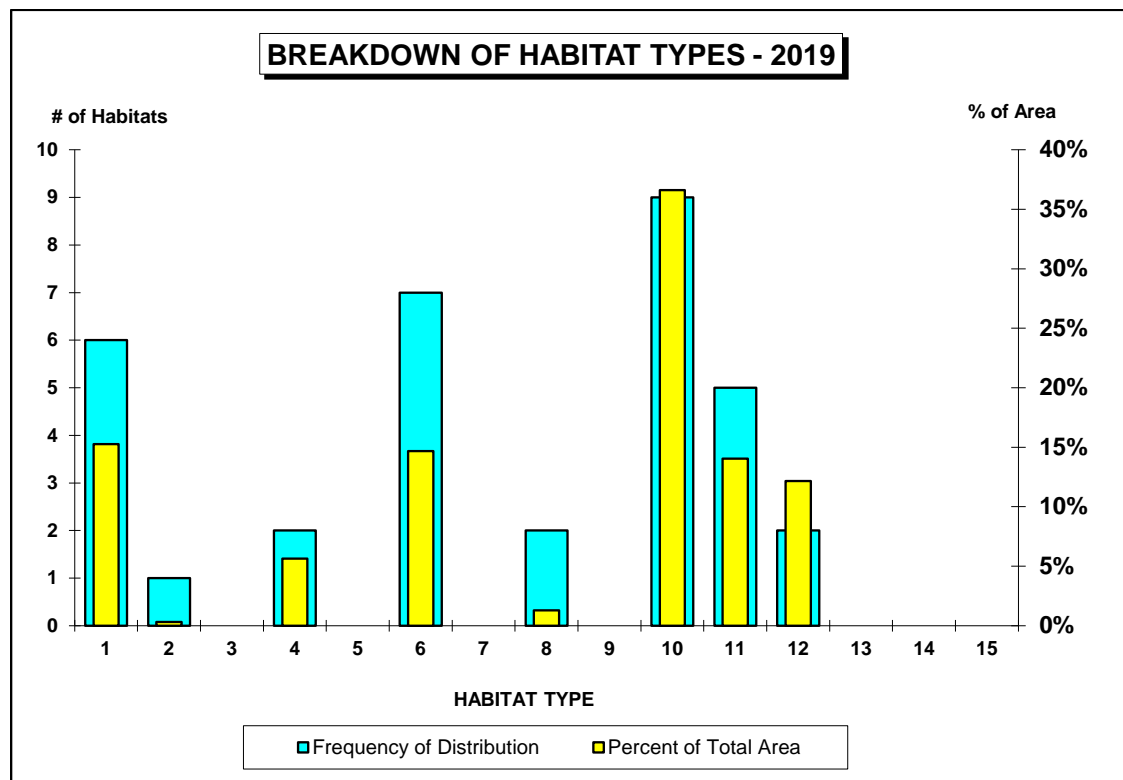
Riffle habitat was dominated by low gradient boulder riffles (Figure 3). The low gradient boulder riffle form (Type 10) was the most common habitat type in terms of meso-habitat units and of wetted area and accounted for 37% of the total reach. Embedded in-channel boulders are providing velocity shelter and in-channel cover for resident fish in these habitats. Low gradient cobble dominated riffles (Type 11) were the next most common riffle habitat form, accounting for 14% of the wetted area of the reach. These riffles tended to exhibit more laminar flow and less habitat complexity, with little or no velocity shelter or cover. Gravel dominated riffles (Type 12) were also present in the reach, accounting for 12% of the wetted area.

Figure 3. Distribution of Meso-Habitat Types as a percentage of # of habitats and as a percentage of wetted perimeter of Reach 5 on Purgatoire River (see Table 1 above for Habitat Type explanation).

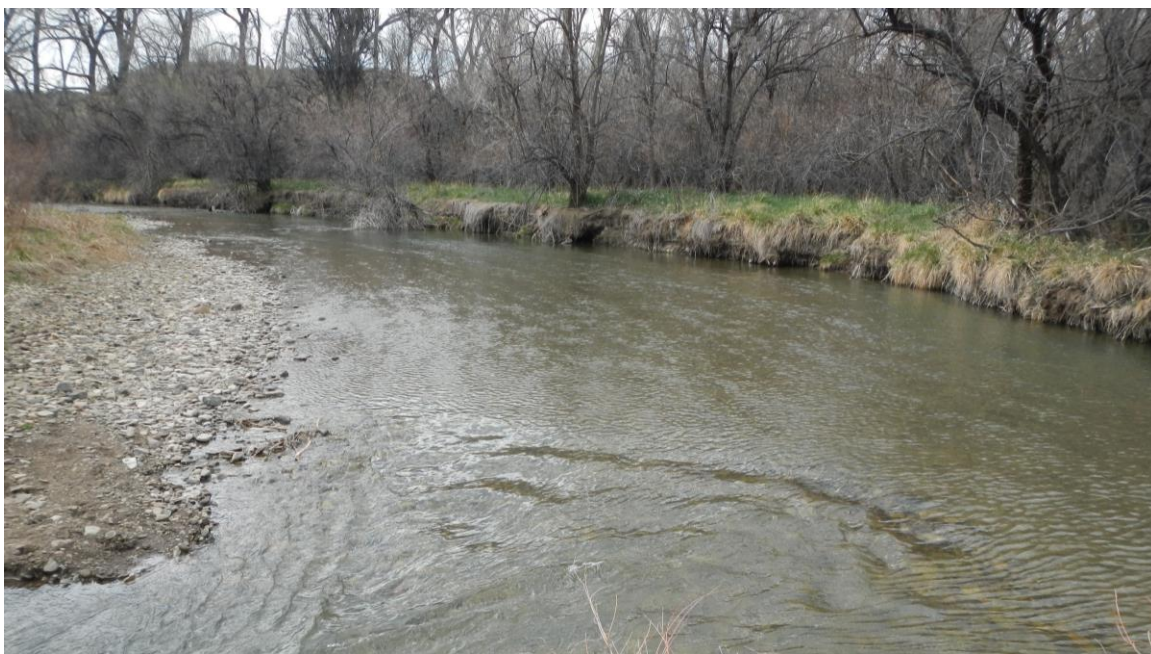
The availability of pool habitat is likely one of the limiting factors to maintaining a robust and sustainable fishery. Pool habitats comprise approximately 30% of the total wetted area. Lateral scour pools (Type 6) are the most abundant, comprising 15% of the total wetted area of the reach (Figure 3). Lateral scour pools are a common feature in C channels, and we would expect this to be the dominant form within the study reach. Trench pools were the next most common pool type, accounting for 6% of the wetted area of the reach, and were mostly associated with constrictions in the channel due to rip-rap or vegetation along the river bank. A single secondary channel pool was observed in the reach, associated with the same island creating the secondary channel riffles described previously. Distribution of meso-habitat pool type was relatively unchanged from 2015. The average wetted width of all pool types found within the reach was 30 feet.

Typical lateral scour pool (Type 6) within the Purgatoire River study reach.

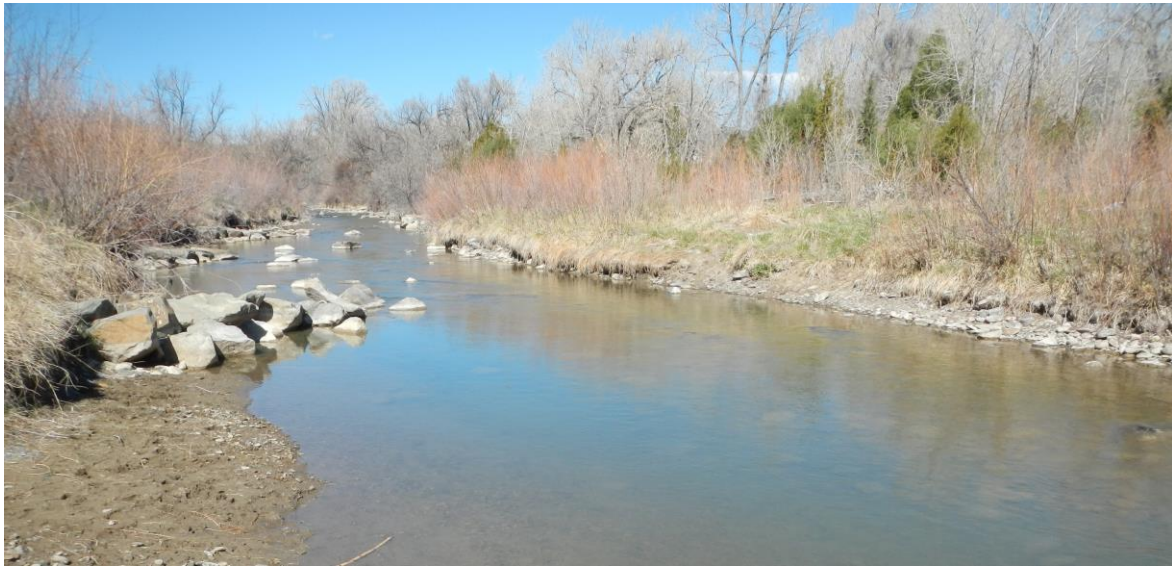
Boulder vanes and micro-vortex structures within the Purgatoire River study reach.
